State of Nevada  
Department of Wildlife  
Gallagher Fish Hatchery  
Facility Condition Analysis

# GALLAGHER FISH HATCHERY

**Site Number: 9881**  
**STATE OF NEVADA PUBLIC WORKS DIVISION**  
**FACILITY CONDITION ANALYSIS**

Report Printed in April 2013

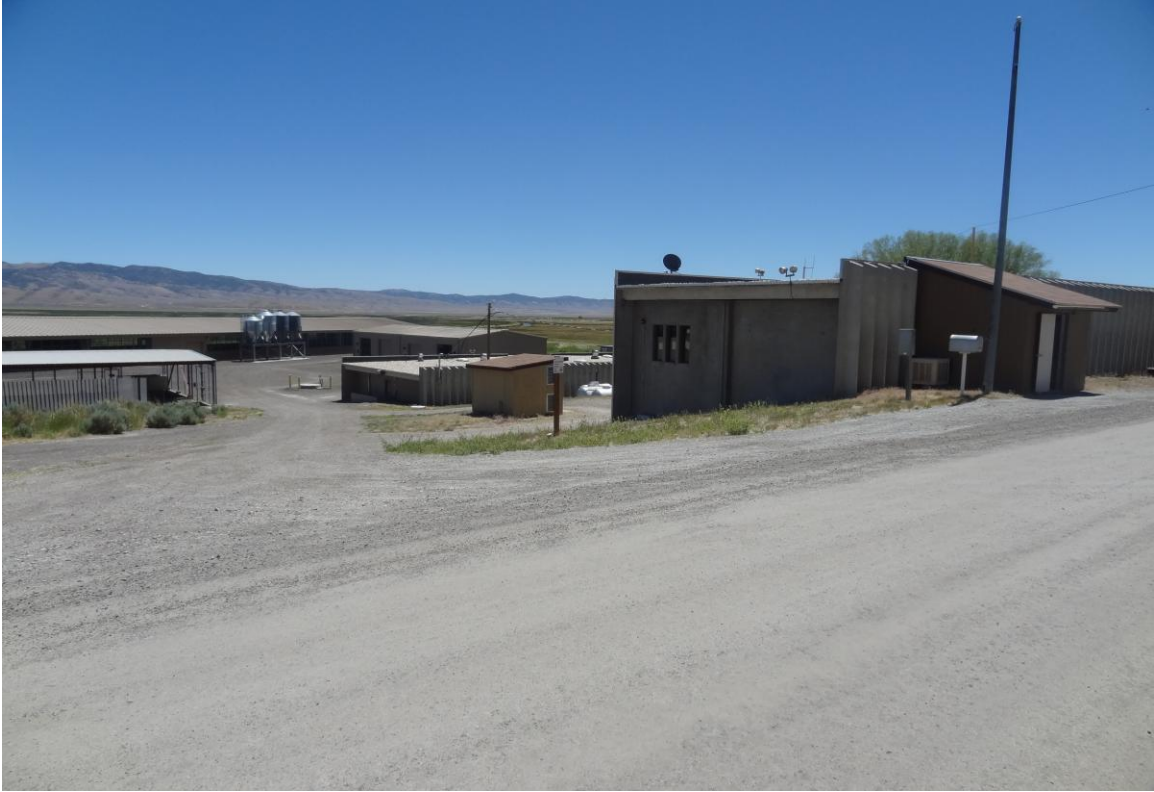
Gallagher Fish Hatchery Site – FCA Site #9881  
Description: Off-site parking along road at office entrance.

The main power line for the site is on the west side of the road and crosses the road to connect to the Office building. The pole is not tall enough to raise the lines above the height of large trucks and the line has been broken in the past. This project recommends working with the utility company to either provide a taller pole or bury the lines under the road. The estimate is based on the state providing all funding for the work.

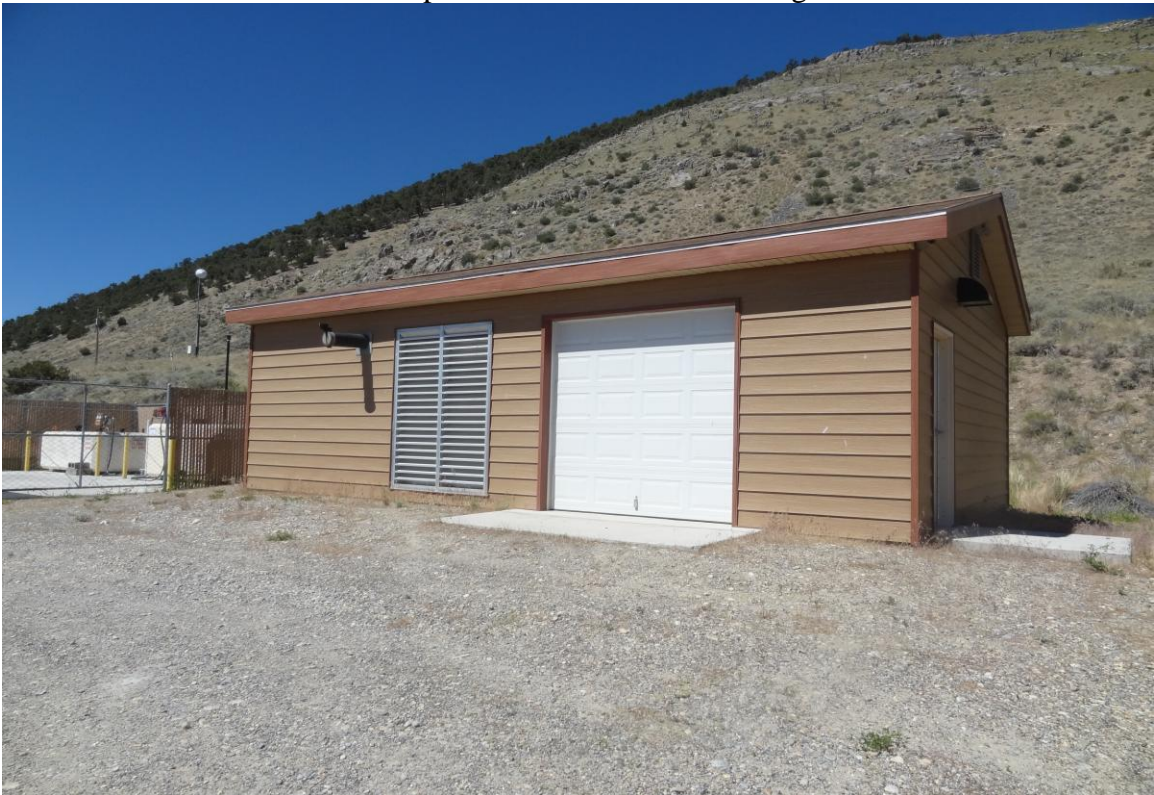
Emergency Generator Building – FCA Building #3142  
Description: Exterior of the building.

The interior finishes are in fair condition. It is recommended that the interior walls and ceilings be painted at least once in the next 4-5 years and that this project be scheduled on a cyclical basis to maintain the integrity of the structure. Prior to painting, all surfaces should be repaired and prepped.

It is important to maintain the finish, weather resistance and appearance of the building. This project would provide funding to protect the exterior of the building excluding the roof. Included in the cost is cleaning the vinyl siding and caulking of the flashing, fixtures and all other penetrations. It is recommended that the building be cleaned and caulked in the next 4-5 years and that this project is scheduled on a cyclical basis to maintain the integrity of the structure.

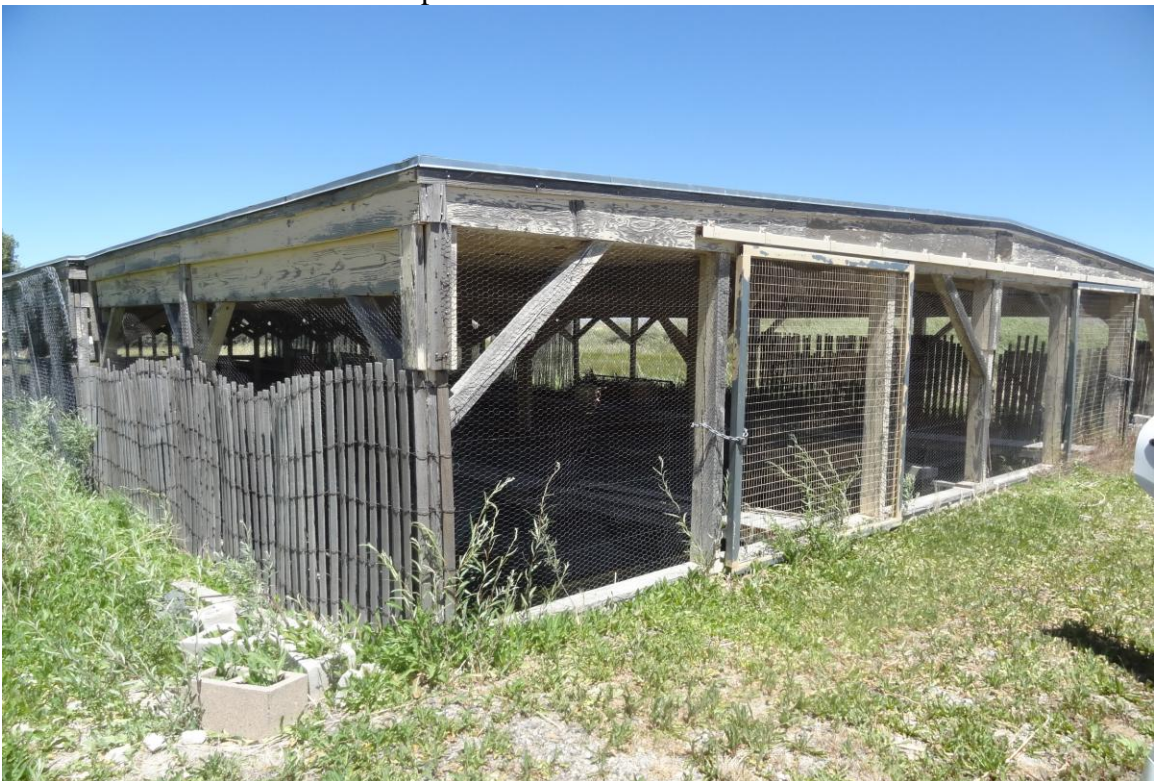
Gallagher Fish Hatchery Shade Shelter North – FCA Building #0935

The Gallagher Fish Hatchery Shade Shelter North is located approximately 1 mile north of the main Hatchery site. The wood post and beam structure with concrete raceways is in poor to fair condition. The facility is no longer in use.

The structure is delapidated and deteriorating and is over 50 years of age. It is no longer in use. This project would provide funding for the demolition and disposal of the structure.

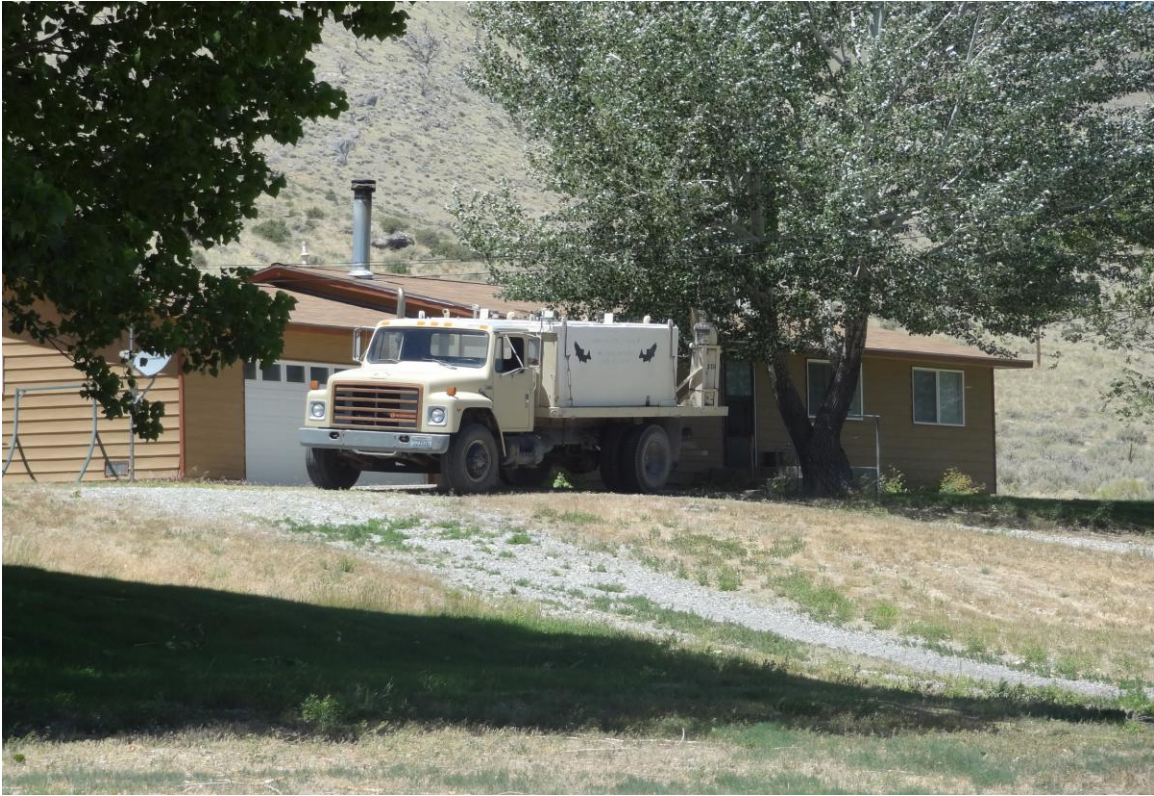
Gallagher Fish Hatchery Residence #6 – FCA Building #0934  
Description: Exterior of the building.

The existing concrete driveway is cracked, spalling and presents a tripping hazard to pedestrians. Exposure to the weather has contributed to the damage and deterioration. It is believed the concrete is part of the original construction. This project would provide funding for the removal and disposal of the existing concrete and the installation of a new 4" thick concrete driveway. This project should coincide with other concrete work recommended for the site. This project or a portion thereof was previously recommended in the FCA report dated 08/17/2005. It has been amended accordingly to reflect conditions observed during the most recent survey date of 06/27/2012.

The interior finishes are in fair condition. It is recommended that the interior walls and ceilings be painted at least once in the next 2-3 years and that this project be scheduled on a cyclical basis to maintain the integrity of the structure. Prior to painting, all surfaces should be repaired and prepped. An epoxy-based paint should be utilized in wet areas for durability.

It is important to maintain the finish, weather resistance and appearance of the building. This project would provide funding to protect the exterior of the building excluding the roof. Included in the cost is cleaning the vinyl siding and caulking of the windows, flashing, fixtures and all other penetrations. It is recommended that the building be cleaned and caulked in the next 5-7 years and that this project is scheduled on a cyclical basis to maintain the integrity of the structure.

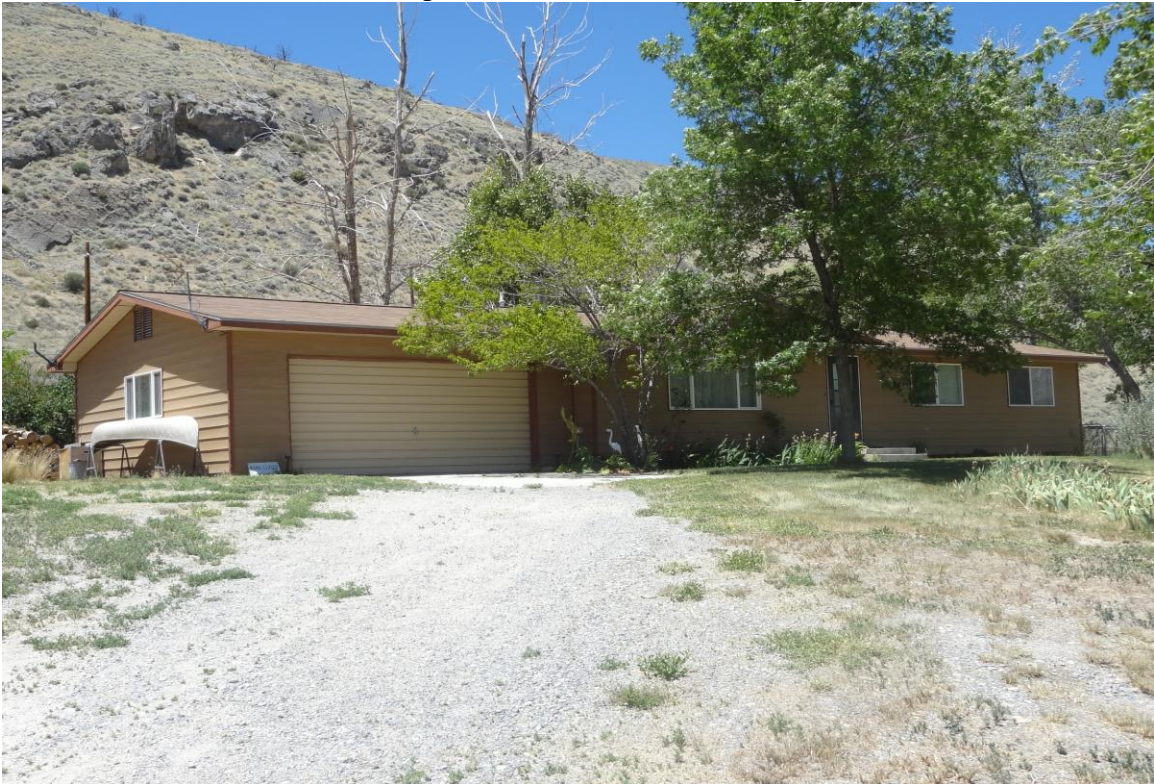
Gallagher Fish Hatchery Residence #5 – FCA Building #0933  
Description: Exterior of the building.

The existing concrete driveway is cracked, spalling and presents a tripping hazard to pedestrians. Exposure to the weather has contributed to the damage and deterioration. It is believed the concrete is part of the original construction. This project would provide funding for the removal and disposal of the existing concrete and the installation of a new 4" thick concrete driveway. This project should coincide with other concrete work recommended for the site. This project or a portion thereof was previously recommended in the FCA report dated 08/17/2005. It has been amended accordingly to reflect conditions observed during the most recent survey date of 06/27/2012.

The interior finishes are in fair condition. It is recommended that the interior walls and ceilings be painted at least once in the next 2-3 years and that this project be scheduled on a cyclical basis to maintain the integrity of the structure. Prior to painting, all surfaces should be repaired and prepped. An epoxy-based paint should be utilized in wet areas for durability.

It is important to maintain the finish, weather resistance and appearance of the building. This project would provide funding to protect the exterior of the building excluding the roof. Included in the cost is cleaning the vinyl siding and caulking of the windows, flashing, fixtures and all other penetrations. It is recommended that the building be cleaned and caulked in the next 5-7 years and that this project is scheduled on a cyclical basis to maintain the integrity of the structure.

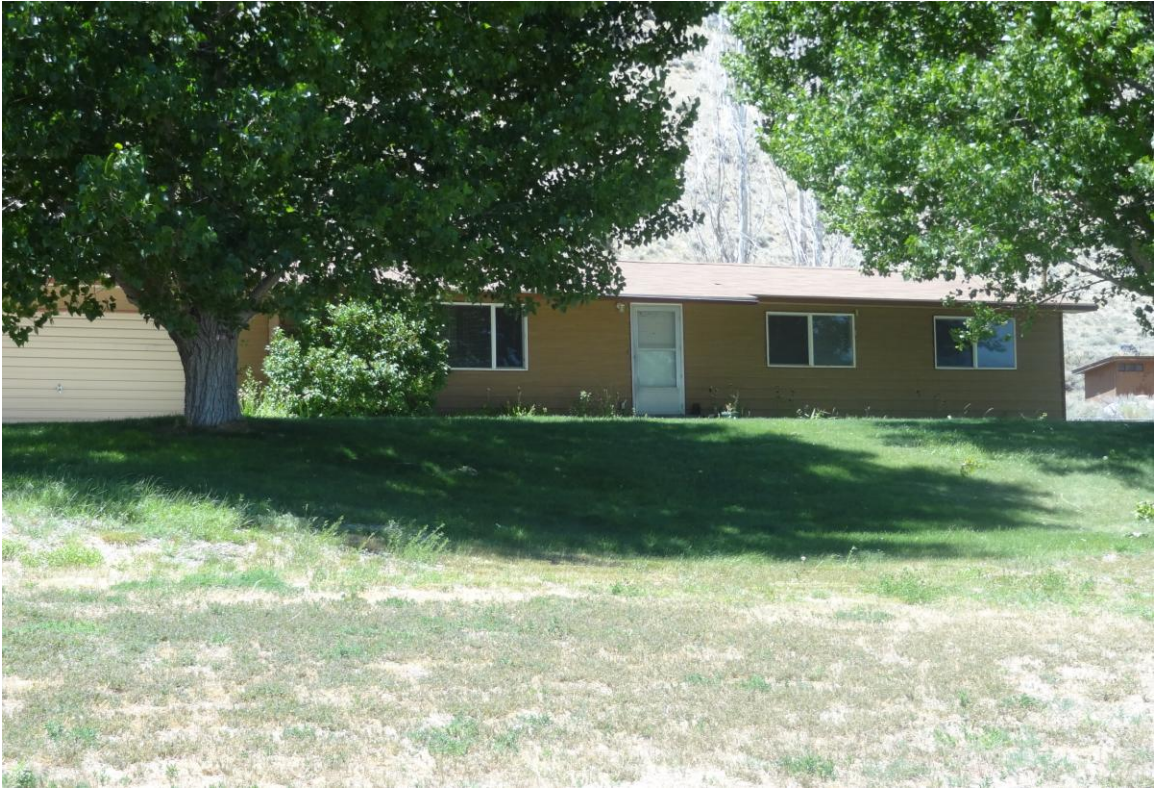
Gallagher Fish Hatchery Residence #4 – FCA Building #0932  
Description: Exterior of the building.

The existing concrete driveway is cracked, spalling and presents a tripping hazard to pedestrians. Exposure to the weather has contributed to the damage and deterioration. It is believed the concrete is part of the original construction. This project would provide funding for the removal and disposal of the existing concrete and the installation of a new 4" thick concrete driveway. This project should coincide with other concrete work recommended for the site. This project or a portion thereof was previously recommended in the FCA report dated 08/17/2005. It has been amended accordingly to reflect conditions observed during the most recent survey date of 06/27/2012.

The interior finishes are in fair condition. It is recommended that the interior walls and ceilings be painted at least once in the next 2-3 years and that this project be scheduled on a cyclical basis to maintain the integrity of the structure. Prior to painting, all surfaces should be repaired and prepped. An epoxy-based paint should be utilized in wet areas for durability.

It is important to maintain the finish, weather resistance and appearance of the building. This project would provide funding to protect the exterior of the building excluding the roof. Included in the cost is cleaning the vinyl siding and caulking of the windows, flashing, fixtures and all other penetrations. It is recommended that the building be cleaned and caulked in the next 5-7 years and that this project is scheduled on a cyclical basis to maintain the integrity of the structure.
